THE EFFECT OF VACUUM REFLOW PROCESSING ON SOLDER JOINT VOIDING AND THERMAL FATIGUE RELIABILITY

Richard Coyle¹, Dave Hillman², Michael Barnes³, David Heller³,
 Charmaine Johnson¹, Richard Popowich¹, Richard Parker⁴,
 Keith Howell⁵, Joerg Trodler⁶, Adam Murling⁷

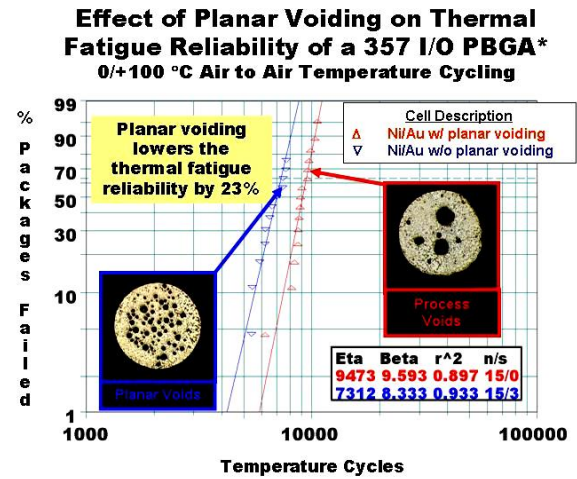
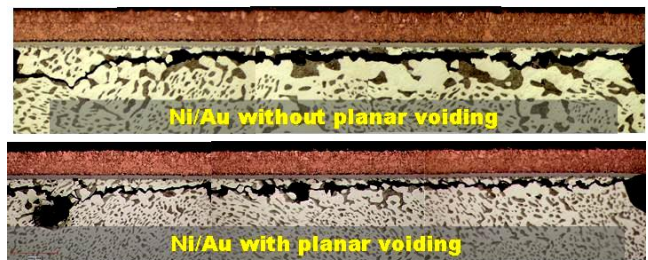
Figure 3. The Weibull plot illustrates the influence of planar microvoiding on thermal fatigue reliability. The imbedded planar or flat section photomicrographs show the reduction in solder joint attachment area caused by planar voiding. The lower photomicrographs are fatigue failures that show that the planar microvoiding is not always obvious in orthogonal cross sections [9].

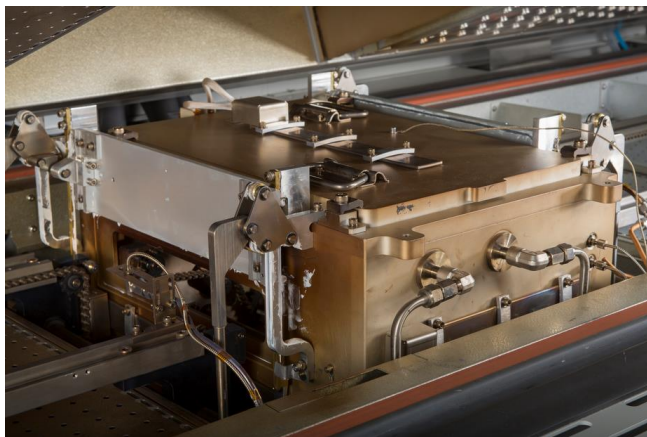
Figure 6. Vacuum reflow chamber shown within the convection reflow oven.

The vacuum chamber located within the convection reflow oven is shown in Figure 6 with the vacuum doors open, ready to receive a substrate.

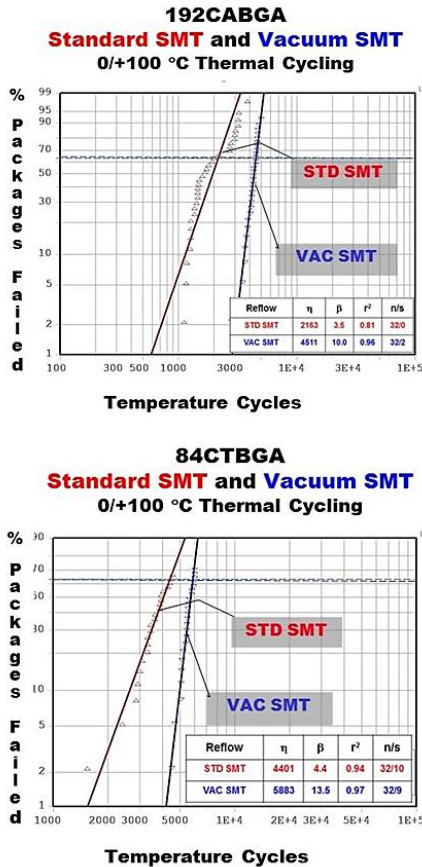
Figure 10. The Weibull distribution plots for the 192CABGA and 84CTBGA packages from the 0/100 °C thermal cycling showing the improved reliability after eliminating voiding with vacuum SMT processing.

Figure 10 and Figure 11 are Weibull distribution plots from the 0/100 °C and -55/125 °C thermal cycling tests respectively. Table 6 provides a summary of the Weibull statistics for those two tests.

The thermal cycling results show a clear improvement in characteristic lifetime (reliability) and Weibull slope (data quality) with vacuum processing. Although BGA solder joint voiding very often does not present an attachment reliability
